Preliminary Assessment Report Northrop (Y-19) Fullerton, Orange County, California

June 2017

Prepared for: U.S. Environmental Protection Agency Region 9

> Prepared by: Weston Solutions, Inc. 1340 Treat Blvd., Suite 210 Walnut Creek, CA 94597

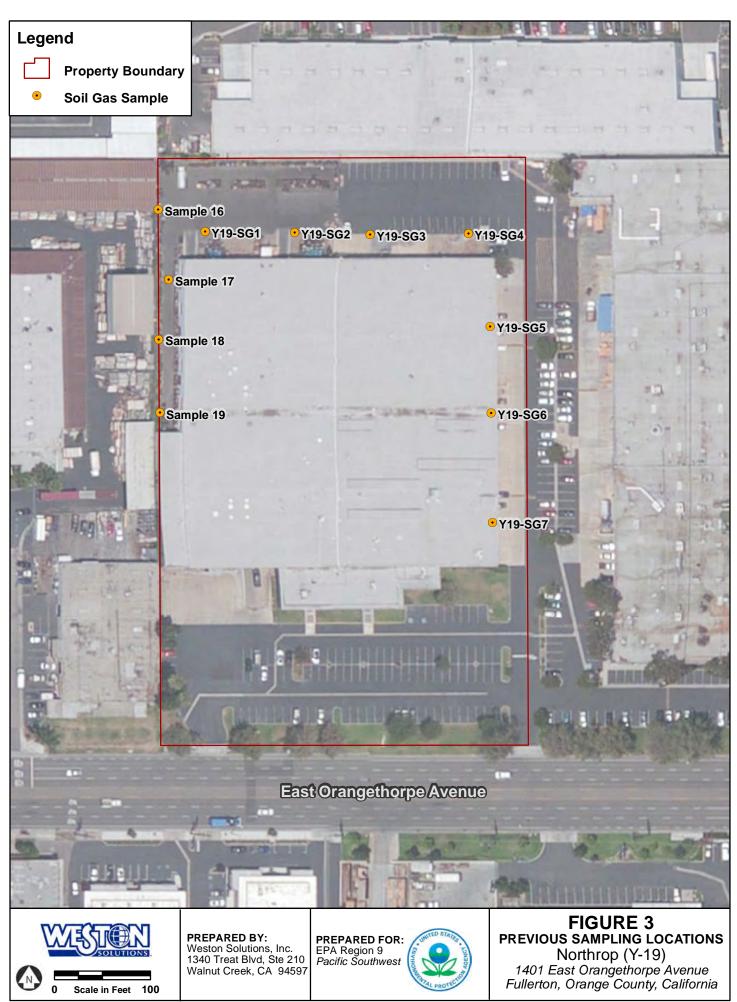
In 1992, RWQCB was investigating groundwater contamination beneath a facility located at 800 South Raymond Avenue, approximately 700 feet northwest of the Northrop site. As part of the investigation, four soil gas samples were collected adjacent to the former railroad tracks along the western border of the property. The investigation showed the presence of a significant TCE and PCE hot spot on the Northrop site. It was recommended that a soil investigation be conducted onsite to further delineate the VOC soil contamination. Results are presented in Table 1, and approximate sample locations are presented in Figure 3 (RWQCB, 1992).

In 2009, a soil gas survey was conducted at the Northrop site. Seven sample locations along the northern and eastern borders of the building were sampled at depths of 10 feet and 20 feet below ground surface (bgs). TCE concentrations were all non-detect with the exception of sample Y19-SG2, located adjacent to the former hazardous waste storage area, where TCE was detected at 8.3 micrograms per liter (μ g/L) of gas in the 10 foot bgs sample and 17 μ g/L of gas in the 20 foot bgs sample. PCE concentrations were non-detect in all of the 20 foot bgs samples and ranged from 1.5 μ g/L of gas to 3.0 μ g/L of gas in the 10 foot bgs samples. The commercial/industrial land use California Human Health Screening Levels (CHHSLs) for PCE and TCE in shallow soil gas are 0.6 μ g/L and 1.77 μ g/L, respectively. 1,1-dichloroethylene (1,1-DCE) was non-detect in all of the samples. Approximate sample locations are presented in Figure 3 (EST, 2009).

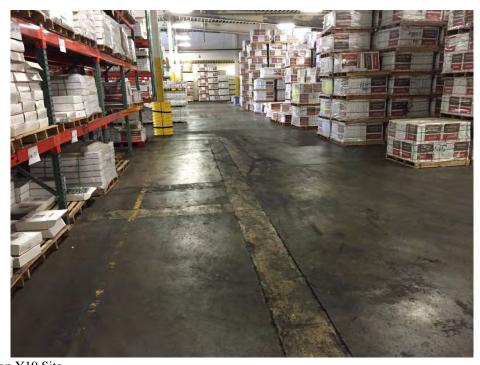
Photograph No.: 1

wholesale/retail warehouse. The only features possibly remaining from the original operation are several backfilled

concrete cutouts in the floor that may represent drains or utility corridors.

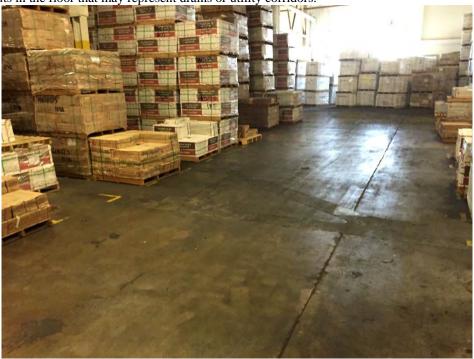
Photograph No.: 2

Direction: North **Photographer:** Ben Castellana **Subject:** The interior of the western half of the building, now occupied by Goton Tiles, a ceramic tile wholesale/retail warehouse, showing product storage and floor cutouts in the concrete.

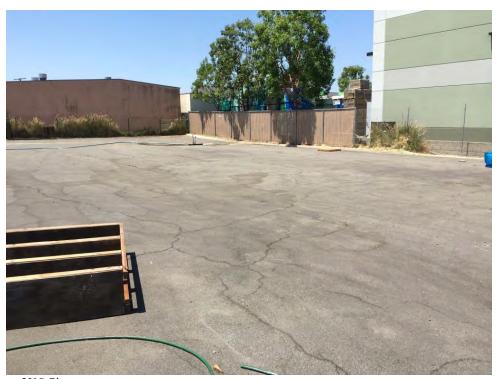
Photograph No.: 3

Direction: Northwest **Photographer:** Ben Castellana **Subject:** The northwest corner of the facility, showing the asphalt surface and a stormwater sump in the far northwest corner. There is a set of hoses leading to the sump that do not serve an obvious purpose.

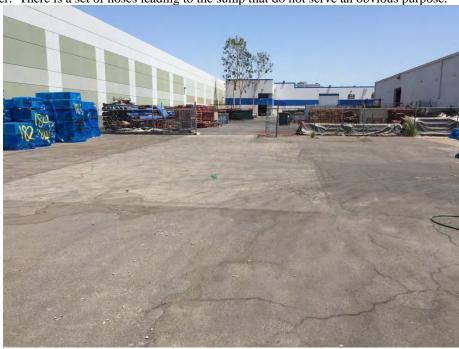
Site: Northrop Y19 Site
Photograph No.: 4
Date: 8-09-2016

Subject: View of the paved lot north of the building, shared by Goton Tiles and Concrete Accessories, Inc. The lot is used to store raw materials and product overstock. Note the asphalt repair in the center of the lot.

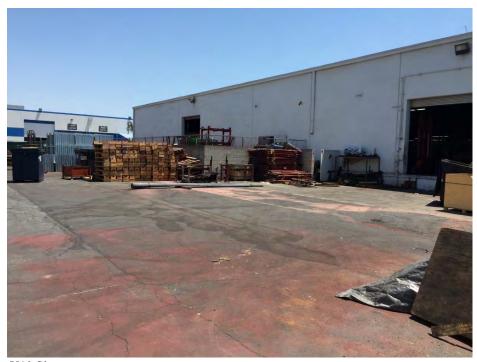
Photograph No.: 5

Direction: Southeast **Photographer:** Ben Castellana **Subject:** Stained asphalt in the lot at Concrete Accessories, Inc. The source of the staining is unclear.

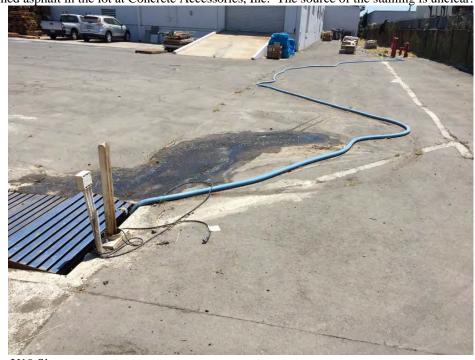
Photograph No.: 6

Subject: A closer view of the sump and associated piping from Photo 4.

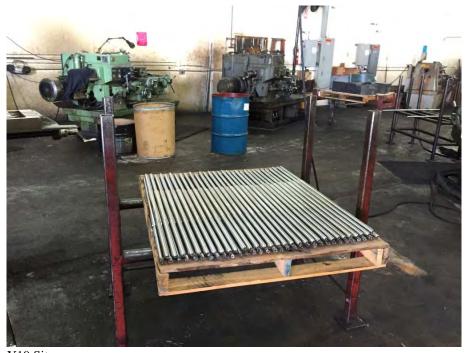
Site: Northrop Y19 Site
Photograph No.: 8

Subject: The interior of Concrete Accessories, Inc., a machine shop that manufactures threaded parts for concrete

reinforcement.

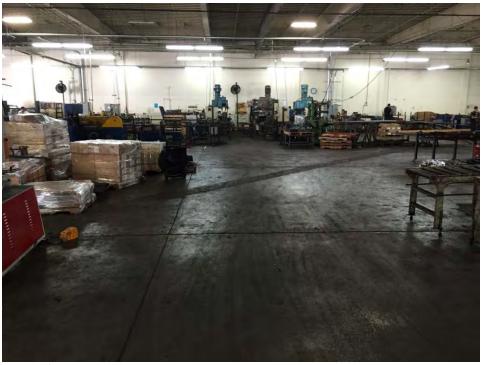
Site: Northrop Y19 Site
Photograph No.: 9
Date: 8-09-2016

Subject: The interior of Concrete Accessories, Inc., a machine shop that manufactures threaded parts for concrete

reinforcement. Note the backfilled cutout in the floor.

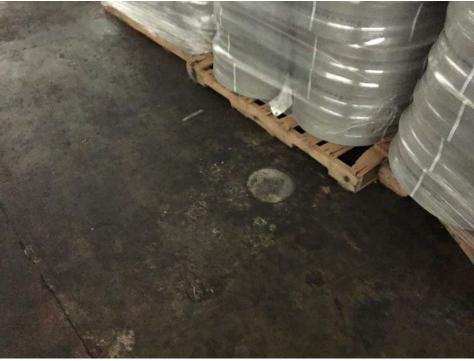
Photograph No.: 10

Direction: West **Photographer:** Ben Castellana **Subject:** Abandoned boring in the floor at Atlas Construction Supply, a warehouse business that occupies the

southeast corner of the building.

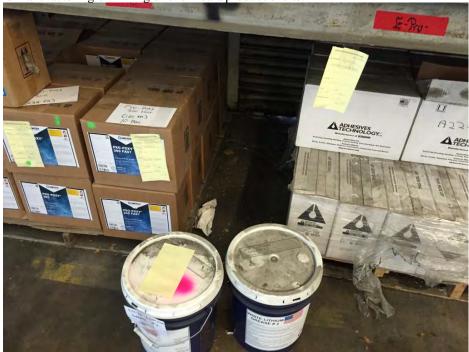
Site: Northrop Y19 Site Photograph No.: 12

Direction: West **Photographer:** Ben Castellana **Subject:** The interior of the warehouse at Atlas Construction Supply. The business is completely flow-

through, with no manufacturing or mixing of chemicals/product onsite.
